# **Facilities Master Planning Report**

**Troy Public Schools**

**Junior- Senior High**

**April, 2010**

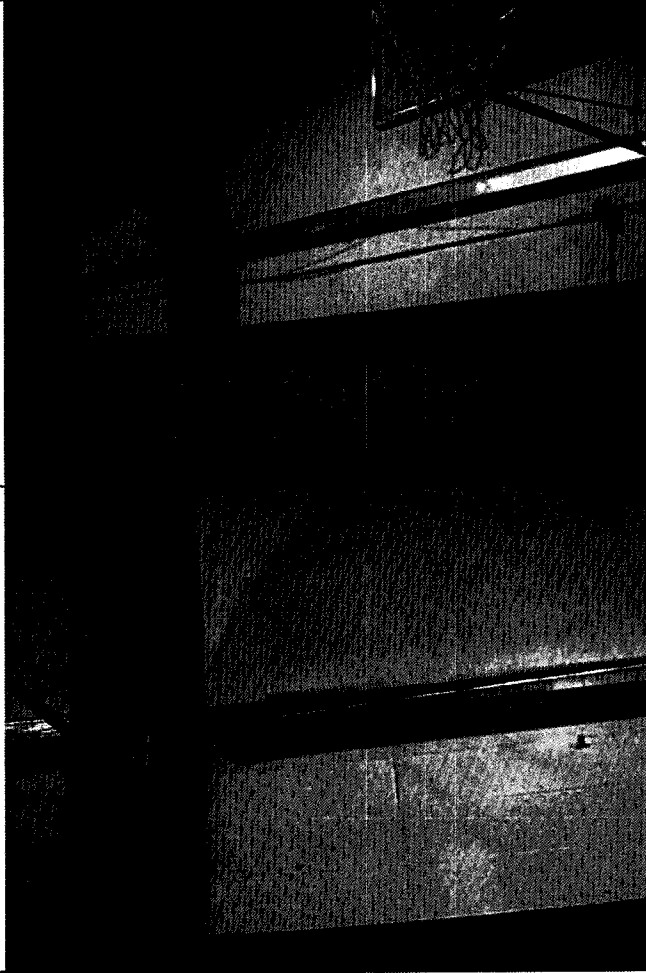
Item # 2M-HS	Description
Component:	Finned-tube steam radiator
Location:	Gymnasium (south wall)
Deficiency:	Not functioning
Consequence:	The gym is currently being heated by the single finned tube unit on the north side which is 50% of the original heating capacity.
Photo #2.1M-HS

Photo #2.2M-HS	
Recommendation:	The first recommendation would be to remove the control valve to the finned-tube steam radiator to investigate as a likely cause of failed operation. Replace control valve if this is determined to be the cause. If the investigation finds the control valve to be working correctly, consideration should be given to replacing the existing system with a new system. Demo existing steam fin tube radiators and associated piping. Provide new ducted air handler unit suspended from roof structure in gymnasium. The new air handler would include a hot water coil, modern comfort controls, and outdoor ventilation air connections. The new system would provide for balanced comfort and better ventilation in the gymnasium.

Cost Estimate:	\$42,086
Priority:	Medium

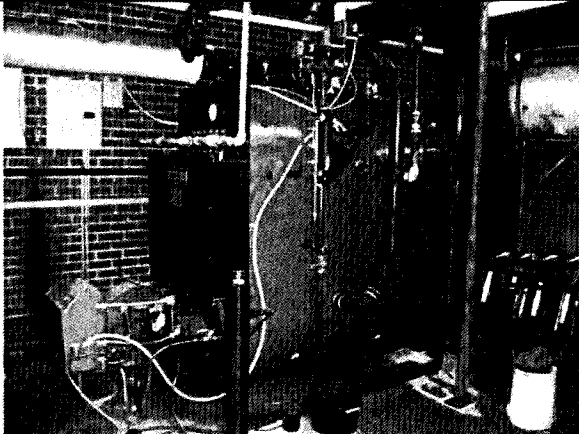
Item # 3M-HS	Description
Component:	High School steam heating plant
Location:	Mechanical room, original high school building
Deficiency:	The existing boiler burns #2 diesel heating oil. Heating oil as a fuel source has become extremely costly with modern fuel rates.
Consequence:	High heating costs
Photo #3.1M-HS

Recommendation:	<p>Convert fuel heating oil to liquid propane. Replace boiler burners and fuel oil distribution system. It is strongly recommended that the steam system be entirely converted over to hot water. Refer to Item # 4M-HS. Remove existing underground fuel oil tank and replace with new underground propane tank at same location.</p> <p>Although propane has a lower heating value per gallon than #2 heating fuel-oil (91,500 Btu/gal as compared to 138,700 Btu/gal), the cost per gallon is significantly less. For propane, the heating value is 65,357 BTU per dollar using a current estimated cost of \$1.40/gal, as compared to diesel which is 51,370 BTU per dollar current estimated cost of \$2.70/gal.</p> <p>The cost saving associated with switching from fuel-oil to propane is estimated to be \$7,200 per year using the rates shown above.</p>

Cost Estimate:	\$30,185
Priority:	Low

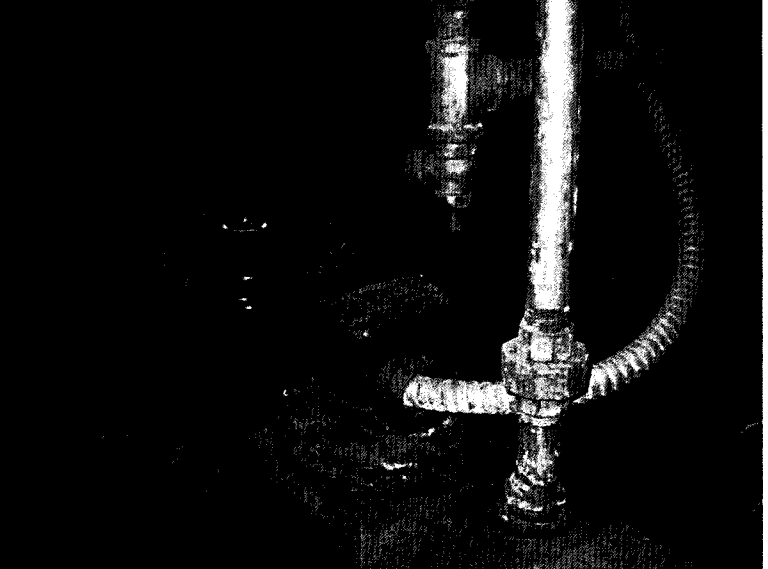
Item # 4M-HS	Description
Component:	High School steam heating boiler and devices
Location:	Original portion of high school building which includes the gymnasium, boys/girls locker rooms and 4 classrooms.
Deficiency:	The 60+ year old steam heating devices, condensate return pumps, piping & components are beyond their useful life and are leaking/failing and in need of replacement.
Consequence:	Inefficient/unreliable heating, demand constant maintenance
Photo #4.1M-HS

Recommendation:	<p>Replace existing fuel oil steam boiler plant with a new high efficiency propane fired condensing gas, hot water boiler plant. This conversion would involve replacing all steam heating devices which include; gymnasium fin tube units, four classroom unit ventilators, and boys and girls locker room unit ventilators.</p> <p>The existing boiler is a conventional, non-condensing unit which loses a significant amount of heat to the atmosphere. The hot combustion gases</p>

<p>from the burning of fuel to heat water contained in a heat exchanger are wasted through the vent stack.</p> <p>The proposed replacement boilers would be properly-sized, premium-efficiency, condensing gas units capable of full modulation with a 5 to 1 turndown ratio or higher. The new boilers would be capable of achieving a maximum operating efficiency of 96%.</p> <p>In a condensing boiler working at peak efficiency, the water vapor produced by the burning fuel in the boiler is condensed back into liquid water. Provided the returning water is sufficiently cool, the steam condenses to liquid water. Some of the extra efficiency of the condensing boiler is due to the cooling of the exhaust gases, but the majority of the energy recovered is from the condensation of the water vapor in the exhaust gases. This releases the latent heat of vaporization of the water into the heat exchanger.</p> <p>In addition, modern condensing boilers have microprocessor-controlled combustion that modulates the quantity of gas/air fuel mixture which is supplied to the burner using an algorithm that considers outdoor air temperature, water temperatures supplied and returned to the boiler, and time at a specific temperature. Sophisticated algorithms learn the building requirements at specific outdoor air temperatures, more successfully returning cool water that condenses the vented exhaust gases and recovering the heat of vaporization. Modulating control units also minimize on-off cycling to increase efficiency. They attempt to supply only the amount of heat to the building that the building loses at a specific outdoor air temperature.</p> <p>Although propane has a lower heating value per gallon than diesel (91,500 Btu/gal as compared to 138,700 Btu/gal), the cost per gallon is significantly less. For propane, the heating value is 65,357 BTU per dollar using a current estimated cost of \$1.40/gal, as compared to diesel which is 51,370 BTU per dollar current estimated cost of \$2.70/gal.</p> <p>The cost saving associated with switching to propane and replacing the boiler with a high efficiency boiler is estimated to be \$16,561 per year using the fuel prices listed above.</p>

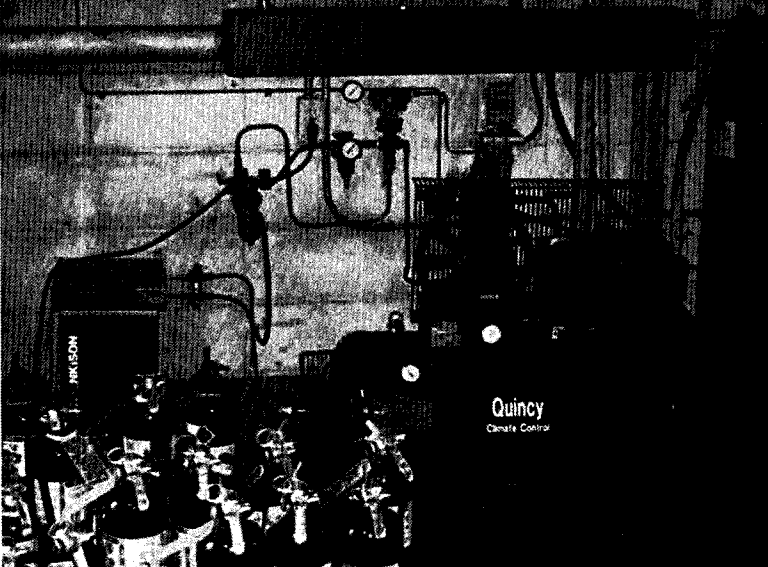
Item # 6M-HS	Description
Component:	Central heating system's pneumatic controls
Location:	Entire facility, classrooms, offices and boiler room
Deficiency:	Antiquated system, requires air compressor, has limited control features
Consequence:	Inefficient operation, limited user control strategies
Photo #6M-HS

Recommendation:	<p data-bbox="451 909 1445 947">Replace existing pneumatic controls with modern direct digital controls.</p> <p data-bbox="451 989 1445 1262">This recommendation would involve replacing the existing pneumatic controls systems and components with a modern, computer-based, direct-digital control (DDC) energy management control system (EMCS). DDC systems improve performance by; control precision, systems coordination, optimum start, outdoor air reset, demand controlled ventilation, diversity analyses, system load tracking, monitoring and maintenance information, trend information and history data.</p> <p data-bbox="451 1304 1445 1766">DDC EMCSs replace conventional pneumatic or electromechanical HVAC control systems with equipment capable of performing not only control but energy management and system diagnostic functions in the environment of a centralized computer network. An EMCS accepts analog, discrete, and digital input from remote sensors and devices, processes the data, and then controls remote mechanical equipment. An EMCS inherently has more accurate control because it reduces the drift, maintenance and recalibration problems common with pneumatic control systems. Additionally, an EMCS can make all facilities function more efficiently when the gathered data are compiled into useful, pertinent reports. Quality control, production, research, and maintenance will all benefit from the increased information flow when it is properly managed.</p> <p data-bbox="451 1808 1445 1948">Conventional pneumatic and electric control employs subsystems and components that traditionally operate without the coordination and sharing of information available with DDC systems. DDC systems integrate subsystems and components to work together, to share information, and to</p>

<p>maximize energy efficiency of the environmental conditioning system. This integration of subsystems maximizes energy efficiency by reducing energy-wasting operating times and conflicting zone conditioning requirements.</p> <p>Sold-state sensors and controllers used in DDC systems have considerable energy-efficiency advantages over conventional pneumatic systems. Substantial advantages are realized in calibration and maintenance, but the critical value lies in the accuracy and reliability of the DDC systems. These features can yield operational energy savings of 15% and greater when compared to the conventional pneumatic system. The inherently precise positioning of control devices with EMCS control loops and blocks are responsible for these energy savings.</p> <p>A DDC system can provide daily building warm-up using temperature sensors in all building zones. A calculation program is used to determine the optimum time to start warm-up, with significant differences from the pneumatic control method. The DDC software allows the operator/manager to gain instant, system-wide access and control from a single computer.</p> <p>Energy savings associated with the implementation of DDC controls has been documented to reduce electric and/or fuel costs by 20% to 50%, and maintenance costs by 40% or more.</p>

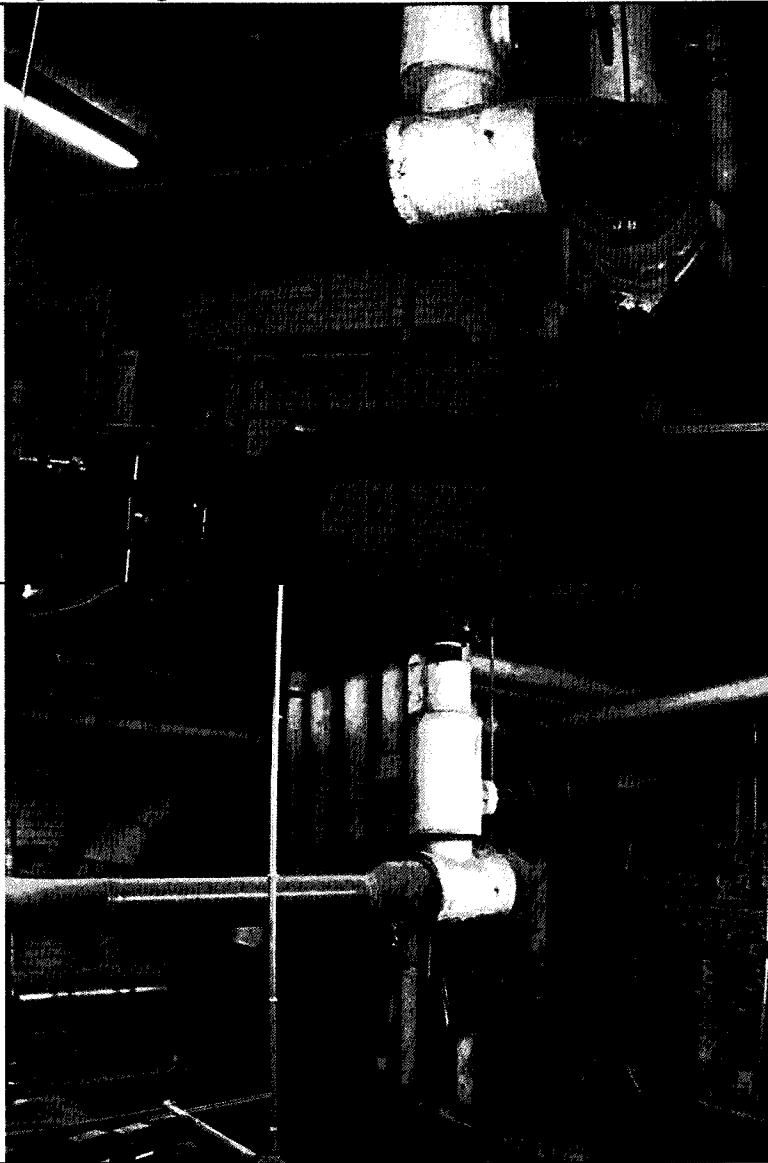
Item # 1M-JH	Description
Component:	Junior High School steam heating plant
Location:	Mechanical room, Junior High School Basement
Deficiency:	The existing boiler burns #2 diesel heating oil. Heating oil as a fuel source has become extremely costly with modern fuel rates.
Consequence:	High heating costs
Photo #1.1M-JH

Photo #1.2M-JH	
Recommendation:	<p>Convert fuel heating oil to liquid propane. Replace boiler burners and fuel oil distribution system. It is strongly recommend that the steam system be entirely converted over to hot water. Refer to Item # 2M-JH. Remove existing underground fuel oil tank and replace with new underground propane tank in same place.</p> <p>Although propane has a lower heating value per gallon than diesel (91,500 Btu/gal as compared to 138,700 Btu/gal), the cost per gallon is significantly less. For propane, the heating value is 65,357 BTU per dollar using a current</p>

<p>estimated cost of \$1.40/gal, as compared to diesel which is 51,370 BTU per dollar current estimated cost of \$2.70/gal.</p> <p>The cost saving associated with switching from fuel-oil to propane is estimated to be \$7810 per year using the rates listed above.</p>
Cost Estimate:	\$29,144
Priority:	Low

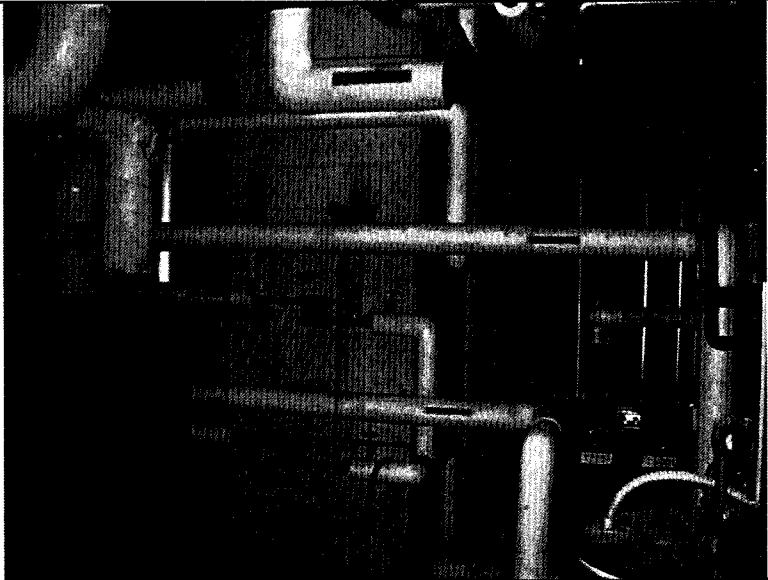
Item # 1M-EL	Description
Component:	Elementary School steam heating piping, steam traps and devices
Location:	Thirteen of the school's nineteen classrooms have steam heating unit ventilators fed from piping in tunnels below grade.
Deficiency:	The 47+ year old steam heating devices, piping & components are antiquated. Some of the steam traps in the tunnels are failing and require attention or replacement.
Consequence:	Unreliable heating, high maintenance demand
Photo #1M-EL

Recommendation:	<p>Investigate and repair faulty steam traps at existing unit ventilators and in the steam tunnels.</p> <p><b>Maintenance of steam traps</b>  Source of the following information is from Spirax Sarco (<a href="http://www.spiraxsarco.com">www.spiraxsarco.com</a>)</p> <p><b>Routine maintenance</b>  Routine maintenance depends on the type of trap and its application. The balanced pressure steam trap for example, has an element which is designed for easy replacement. Changing these on a regular basis, maybe once every three years or so, might seem wasteful in time and materials. However, this practice reduces the need for trap checking and should ensure a trouble free system with minimal losses through defective traps.</p> <p>Routine maintenance which involves cleaning and re-using existing internals uses just as much labor but leaves an untrustworthy steam trap. It will have to be checked from time to time and will be prone to fatigue. Any routine maintenance should include the renewal of any suspect parts, if it is to be cost effective.</p>

Cost Estimate:	\$4,485
Priority:	Medium

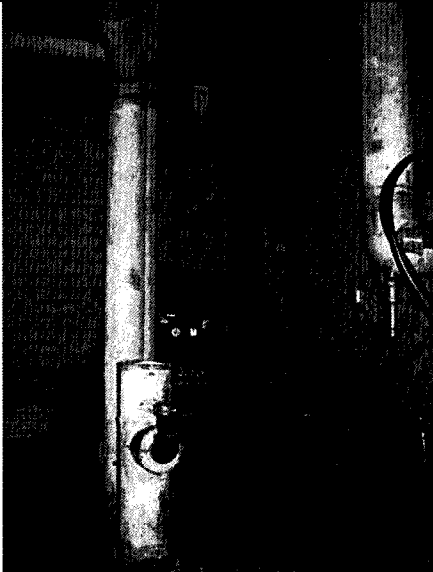
Item # 3M-JH	Description
Component:	Central heating system's pneumatic controls
Location:	Entire facility, classrooms, offices and boiler room
Deficiency:	Antiquated system, requires air compressor, has limited control features
Consequence:	Inefficient operation, limited user control strategies. No night set-back or operational schedule or energy management functions resulting in wasted energy.
Photo #3.1M-JH

Recommendation:	Replace existing pneumatic controls with modern direct digital controls.  See Item #6M-HS for further explanation of replacing existing pneumatic controls with modern direct digital controls.
Cost Estimate:	\$88,479
Priority:	Low

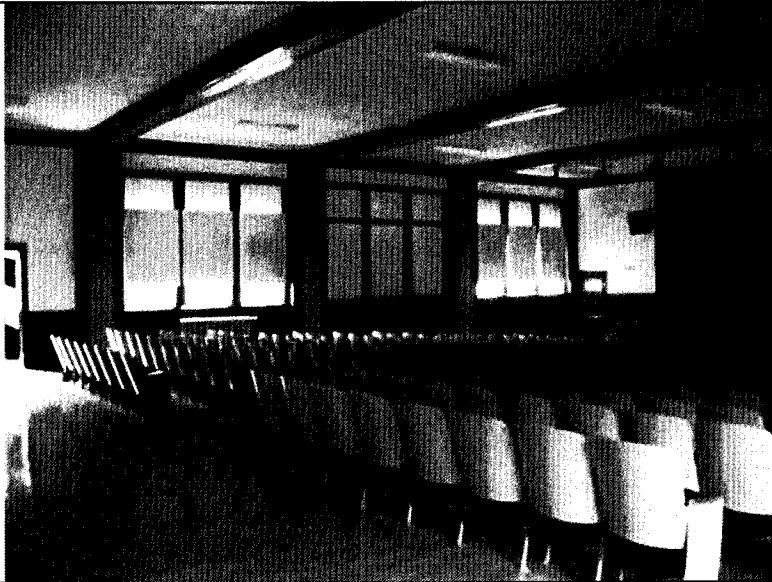
Item # 4M-JH	Description
Component:	Ventilation air systems
Location:	Auditorium
Deficiency:	Outdoor ventilation/relief air systems abandon or inoperable. Code required ventilation air rates for this type of space are 7.5 CFM/person, 10 sq-ft/person. For the 3060 sq-ft auditorium the required ventilation rate is 306 CFM.
Consequence:	No active fresh air ventilation systems for occupants. Ventilation air is required for school's assembly halls/auditoriums per ANSI/ASHRAE standard 62.1.
Photo #4M-JH

Recommendation:	Replace existing steam convector units with new ducted air distribution system. New air handler will include steam or hot water heating coil, modern comfort controls, demand controlled ventilation, and outside ventilation air connection. New air handler could possibly be located in structural space above the auditorium.
Cost Estimate:	\$33,949
Priority:	Low

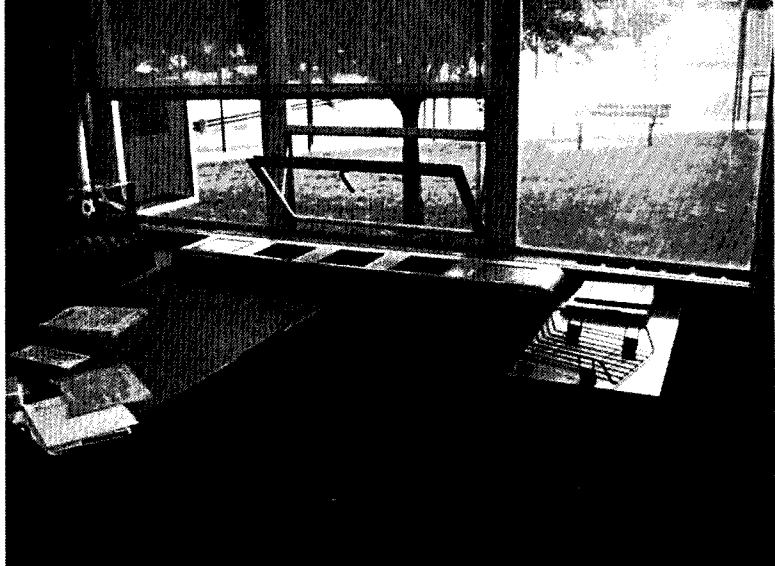
Item # 5M-JH	Description
Component:	4 Original 1950's era, steam-unit ventilators
Location:	4 classrooms in the original, central classroom
Deficiency:	Units are beyond their life-expectancy
Consequence:	Units are unreliable and not energy efficient
Photo #5M-JH

Recommendation:	<p>Remove and replace existing unit ventilators with new classroom ventilators. The new units could utilize the existing steam or be converted to hot water and tied into existing boiler system.</p> <p>Unit ventilators have been used for classroom comfort and learning productivity for over 80 years. New unit ventilators are 65% quieter than previous models and deliver extra cooling capacity for the added ventilation requirements prescribed by American Society of Heating, Refrigerating and Air-Conditioning (ASHREA) Standards. Unit ventilators draw-through design with face and bypass damper control provide superior temperature and dehumidification control. New unit ventilator can be tied into Direct Digital Controls (See Item # 3M-JH). Additional features include, economizer, demand control ventilation (DCV) and part load, variable air options that allow you to reduce operating costs while closely matching classroom comfort requirements</p>

Cost Estimate:	\$32,535
Priority:	Medium

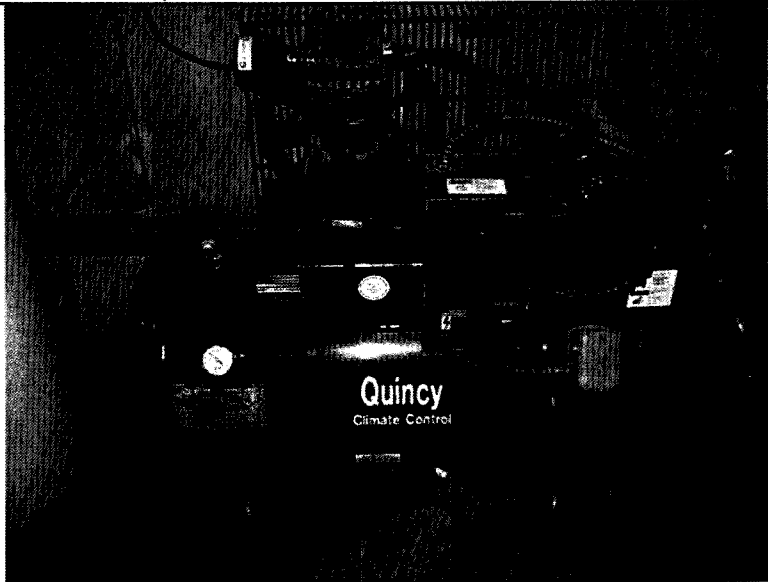
Item # 3M-EL	Description
Component:	Central heating system's pneumatic controls
Location:	Entire facility, classrooms, offices and boiler room
Deficiency:	Antiquated system, requires air compressor, has limited control features
Consequence:	Inefficient operation, limited user control strategies
Photo #3M-EL

Recommendation:	<p>Replace existing pneumatic controls with modern direct digital controls.</p> <p>See Item #6M-HS for further explanation of replacing existing pneumatic controls with modern direct digital controls.</p>
Cost Estimate:	\$124,187
Priority:	Low

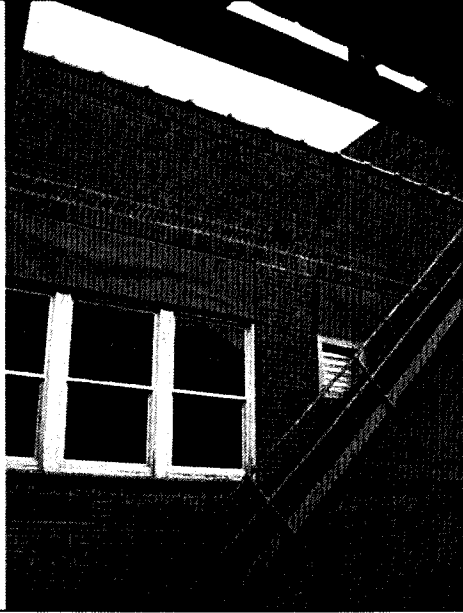
Item # 1E-JH	Description
Component:	Egress Lighting
Location:	Building Exterior
Deficiency:	Lacking emergency egress lighting
Consequence:	Code violation and life safety hazard in the event of power loss. Per IBC 1006.3, in the event of a power failure, an emergency electrical system shall automatically illuminate exterior landings for exit discharge doorways in buildings that have two or more exits.
Photo 1 #1E-JH

Recommendations:	Install new exterior luminaire with remote mounted battery or exterior emergency lighting with integral battery rated for cold weather.
Cost Estimate:	\$4,908
Priority:	High

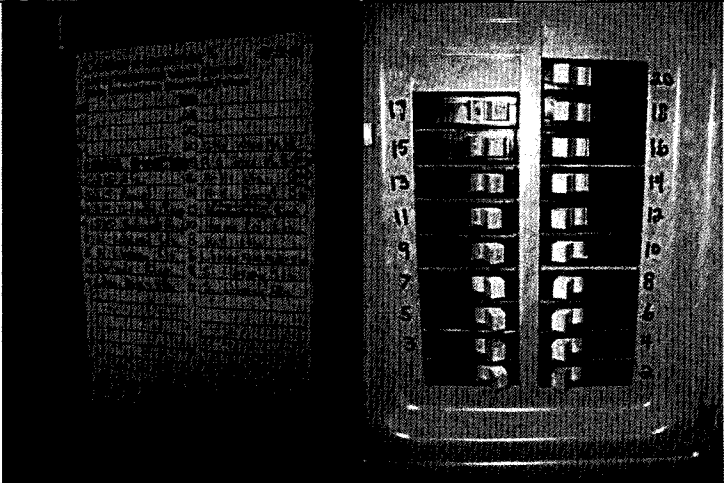
Item # 5E-JH	Description
Component:	Receptacles
Location #1:	Library/Library Storage Areas
Deficiency:	Insufficient quantity of the receptacles
Consequence:	Potential for overloading existing receptacles and circuits. Little room to accommodate electrical needs of future equipment.
Photo 1 #5E-JH

Recommendation:	Locate and provide new receptacles in library to meet the needs of the space. Provide new electrical cable from new receptacle circuits to new 20A breakers in existing hallway panel.
Cost Estimate:	\$7,099
Priority:	Medium

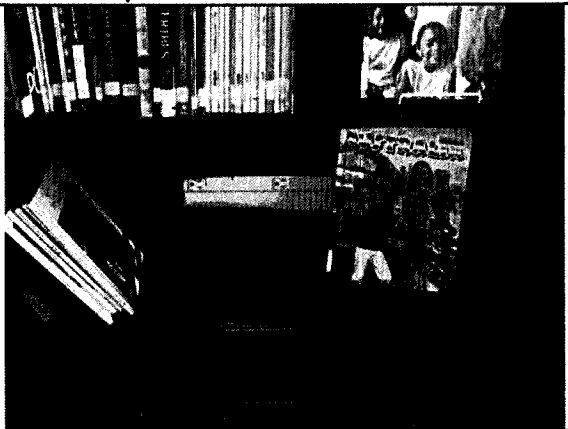
Item # 1E-EL	Description
Component:	Electrical receptacle circuiting
Location:	Multiple classrooms and library
Deficiency:	Insufficient quantity and spacing of electrical receptacles. Most classrooms have no receptacles on their exterior walls. In addition multiple classrooms are currently wired on the same receptacle circuit.
Consequence:	Insufficient power for classroom computers/electronics. There have been multiple problems associated with breakers tripping as a result of this deficiency.
Photo 1 #1E-EL

Recommendation:	Install new convenience receptacles in the classrooms in compliance with NEC codes. This would include receptacles on the exterior walls where there are none. Coordinate the location of additional receptacles to meet the functional needs required by each space. Circuit new receptacles to new 20A/1P breakers in existing load centers (Photo 2). Currently a number of the classrooms share electrical circuits. It is recommended that classrooms receptacles be individually circuited to the electrical panels.

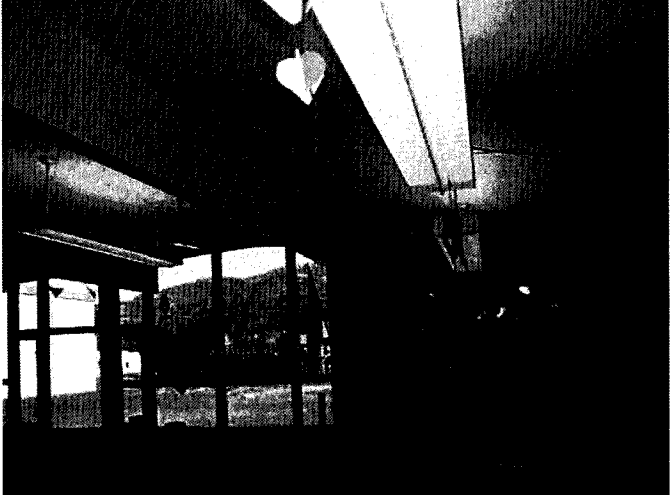
Item # 2E-EL	Description
Component:	(58) 8-ft long, 2-lamp T12 light fixtures (116 lamps total)
Location #1:	Gymnasium (25 luminaires)
Locations #2:	6 Classrooms in addition. (25 luminaires)
Location #3:	Basement (8 luminaires)
Deficiency:	Antiquated and inefficient lighting fixtures/lamps
Consequence:	Inefficient lighting, excess electrical energy costs
Photo #2E-EL

Recommendation:	<p>Replace lighting in gymnasium with 4' T5HO high bay luminaires. These luminaires offer an improved performance and lighting quality over the existing luminaires and result in energy savings if implemented with a revised lighting design. Replace pendant mount luminaires with new high performance luminaires with T5 or T5HO lamping. Replace T12 luminaires in the basement with T5 strip style luminaires.</p> <p>Lighting incentives are available through Bonneville Power. It is recommended that funding grants/rebates for this project be investigated.</p>

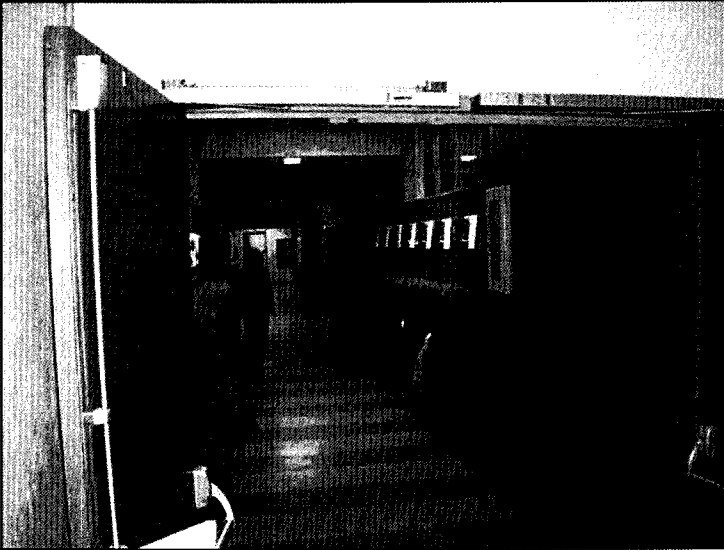
Item # 3E-EL	Description
Component:	Fire Doors
Location #1:	Double doors near 6 classroom addition
Deficiency:	Owner reported the fire doors do not operate properly
Consequence:	Life safety hazard.
Photo #3E-E1

Recommendations:	Install new magnetic door holds. This project will require coordination with an electrical contractor and fire alarm contractor.
Cost Estimate:	\$2,800
Priority:	High

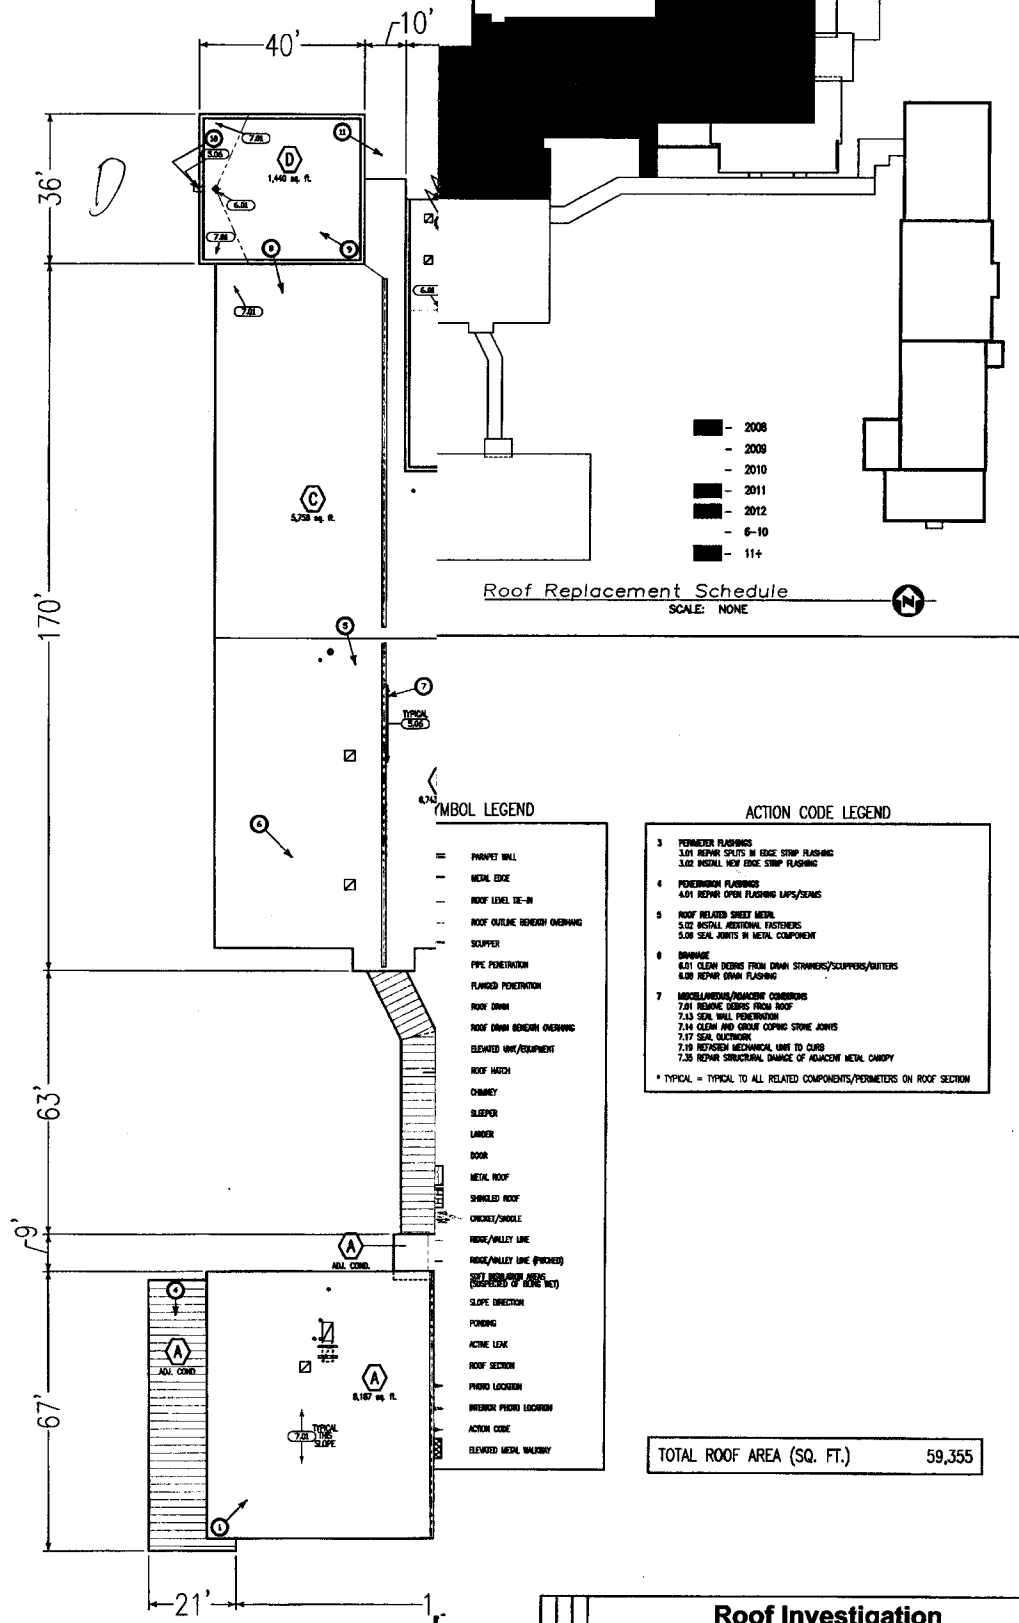
Item # 1G-JH	Description
Component:	Building roof system
Location:	Refer to Roof Investigation Survey prepared by Benchmark Roof & Pavement Consultants, August 2007
Deficiency:	Various minor repairs/maintenance required. (Refer to roof survey report and roof plan R-2)
Consequence:	Potential water leakage
Photo #1G-JH

2	FIELD MEMBRANE
2.07	REPAIR PUNCTURED/DAMAGED MEMBRANE
2.13	REPAIR SEAM VOID
4	PERFORATION FLASHINGS
4.01	REPAIR OPEN FLASHING LAPS/SEAMS
6	DRAINAGE
6.01	CLEAN WEIRS FROM GROUND DRAINERS/SCUPPERS/OUTLETS
6.03	INSTALL NEW GROUND DRAINER
7	MISCELLANEOUS/DAMAGED CONDITIONS
7.23	REPLACE DAMAGED SKYLIGHT
